ANTICORROSION SEALING CAPS FOR MECHANICAL FASTENERS

W. L. MACKIE Engineering Division

12 September 1968

PMR-TM-68-4 (U)

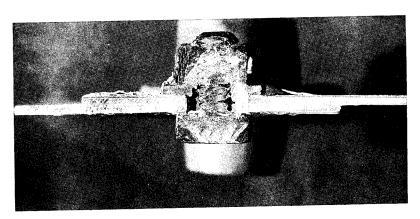
a. Test Specimen. Sealing Cap Partly Removed From Protected (Right-Hand) Carbon Steel Bolt Shows No Corrosion. Unprotected Bolt Has Been Partly Destroyed by Rust.

b. Cross Section of Unprotected Carbon Steel Bolt, Showing Extensive Corrosion.

Figure 7. Steel and Aluminum Test Specimen With Carbon Steel Bolts After 16-Month Weathering Test.

Figure 7a shows protected and unprotected carbon steel bolts on an aluminum/steel specimen. The sealing cap on the left-hand bolt has been partially removed and shows the uncorroded condition of the bolt and nut. The right-hand, unprotected bolt has been partially destroyed by rust. Figure 7b shows section through the unprotected bolt.
